ORS DEMONSTRATION (Oil Removal System) For:

AMBRAKE Inc. Elizabethtown, Kentucky

December 29, 2005

ORS DEMONSTRATION JOB December 29, 2005

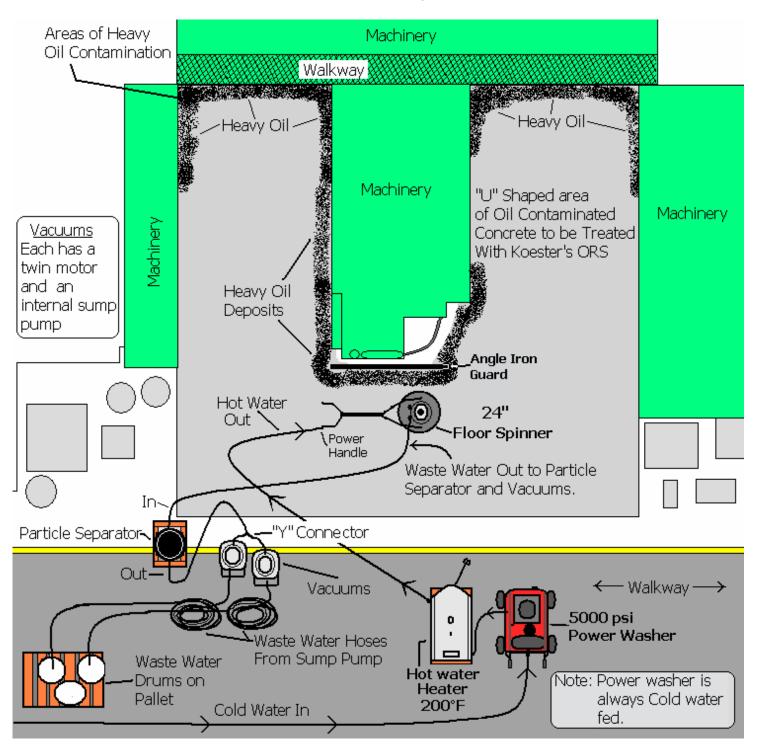
Floor Plan Drawing of ORS Demonstration Area for AMBRAKE Facility Elizabethtown, KY December 29, 2005

- 12:50 p.m. Second foam "carpet" was laid down by the Cothern crew. Extra attention was paid to the areas of heavy oil contamination, (see diagram), and those areas that were contaminated when the debris was blown out from under the machines. The foam was left to sit for approx 1 hour. The crew went to lunch at a local restaurant and some of the Cothern crew was sent to another area of the plant for other duties. Approximately 1.5 gallons of ORS-D special detergent was used for these cleaning procedures
